Technical Bulletin

BULLETIN: TB02-04-02
MODELS: All 2002 ATVs and Motorcycles
ISSUED: 4/5/02
SUBJECT: TDC bolt and TDC washer

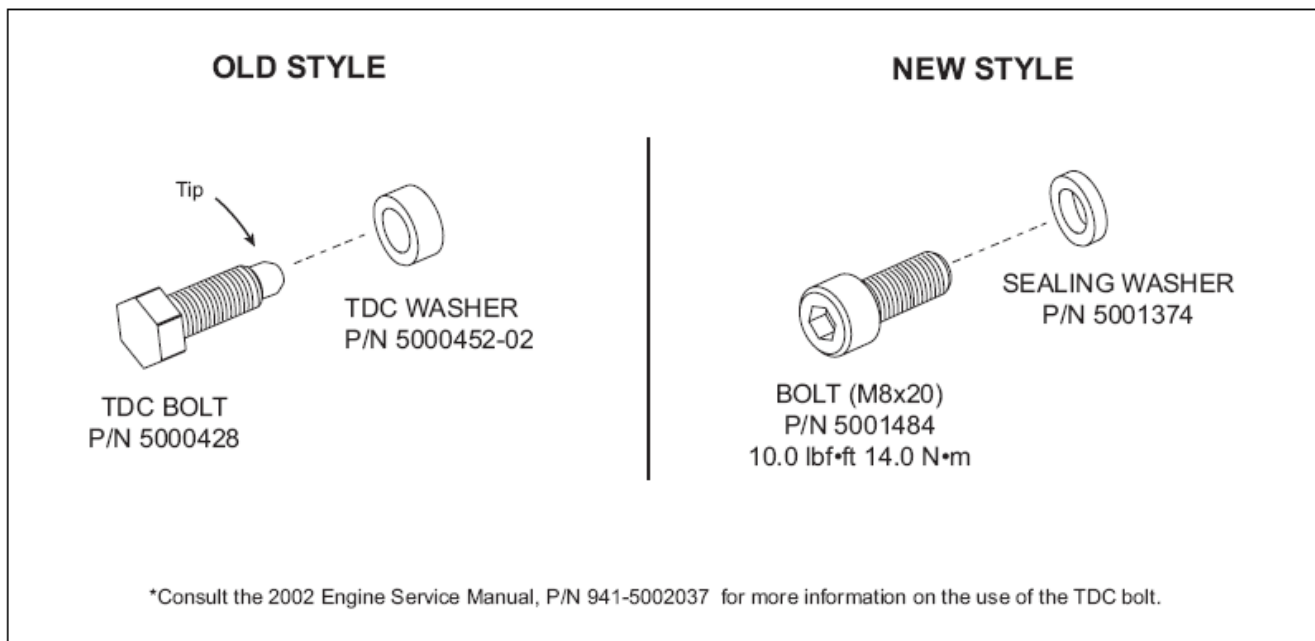
A running change has been made resulting in the removal of the TDC bolt P/N 5000428 and TDC washer P/N 5000452-02 combination from the crankcase cartridge plate assembly for 2002 model ATV and motorcycle engines. Use of the TDC bolt is still suggested for timing chain and camshaft assembly servicing and is now available directly through our parts department. For engines prior to the running change, the TDC bolt and TDC washer were removed and the bolt reinstalled to hold the crankshaft in the top-dead-center position; the tip of the TDC bolt locates into a hole in the left crankshaft half holding the crankshaft in position. The TDC washer and TDC bolt were reinstalled when the service was complete to keep the engine and transmission oils isolated from each other. With the TDC washer installed, the TDC bolt tip was withdrawn from the interior of the crankshaft chamber. For all engines produced after the running change, a bolt P/N 5001484 and sealing washer P/N 5001374 have been installed into the threaded TDC bolt hole in the crankshaft cartridge plate. Both must be removed when using the TDC bolt and reinstalled when completed.
